IMPORTANT WARRANTY INFORMATION

AVOID SEVERE ENGINE DAMAGE & PREMATURE INJECTOR FAILURE

This Technical Bulletin addresses common issues encountered when installing HEUI G2.9 Injectors for the Navistar/International DT466/570 application.

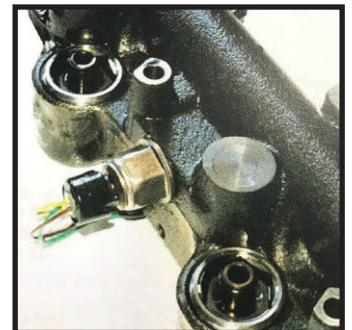
ICP Sensor Location

This issue is commonly a bad ICP Sensor. A vehicle with a bad ICP sensor will start with the sensor unplugged, and will not start with the sensor plugged in. The ICP sensor connector is the second connector from the rear of the valve cover gasket, hidden behind the crankcase vent. Severe high pressure oil leaks could be caused by damaged oil rail seals. These seals must be replaced every time injectors are removed and re-installed. Oil Rail Seal Kit P/N: 522-069. A torn seal can cause a misfire on one cylinder. Multiple bad seals can cause a No Start or Stalling issue.

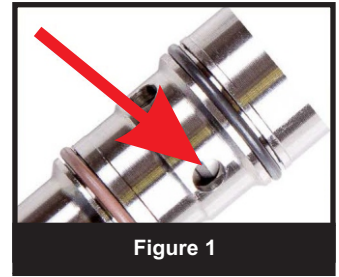
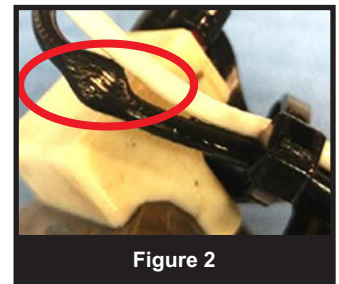
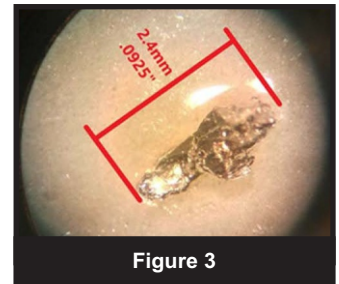
In engines with good compression, this type of failure is commonly caused by insufficient fuel supply pressure or debris entering the injector during the installation process. These injectors are highly susceptible to failure from debris, because there are no filter screens in the fuel inlet of the injector (Figure 1). Warranty analysis commonly reveals dirt and/or metal debris in the fuel side or oil side of the injector (Figure 2). Contamination from metal debris is common in cases where injectors were installed during an engine overhaul. Incorrect maintenance intervals/procedures of the fuel and oil systems can also allow debris to enter the injector and cause failures. Coil wires can be pinched during installation, also causing misfires (Figure 3).

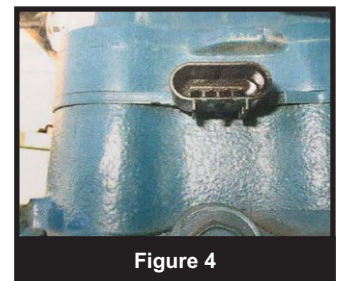
Injector harness failures are common in early applications. The valve cover gasket has integrated circuits for injectors and ICP sensor, and failures from "Oil Wicking" are common (Figure 4). Injector circuit codes and misfires under load are commonly caused by poor connections at the valve cover gasket. Use the latest design with improved electrical locks to avoid this issue. The harness connector in the early applications does not have a secondary lock, allowing it to lose continuity when the engine is torqued up in the chassis. Double check all connectors are secured. There is a TSI letter on an updated lock used on the later engines. TSI Number: 05-12-10 TSI Date: February 2005.

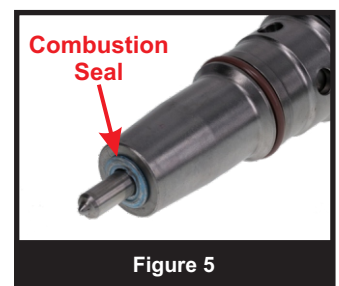
Leaking combustion seal: (Figure 5)

When replacing the injector the combustion seal must be replaced and is included with GB's remanufactured injector. In most cases the combustion seal will remain on the old injector when removed. Verify the seal is present on the injector being replaced, if it is not, inspect the injector bore for the seal and remove as necessary. Inspect the injector bore for damage, contamination and or corrosion. Correct any defects with the injector bore prior to installing the new injector.

NOTICE: Failure to replace the combustion seal and properly torque the injector will result in injector failure and may cause severe engine damage. Failure as a result of these conditions is NOT covered by limited warranty.

- Injector hold down clamp - 10 lbf-ft (13.6 Nm)
- High pressure oil rail/manifold screws - 20 lbf-ft (27 Nm)
